TECHNICAL SERVICE BULLETIN

Product: VIPER FCB

Subject: MOTOR BOARD ERRORS ("Motor Stall," "No Motor," or "MTR Comm Error")

Date: AUGUST 6, 2013

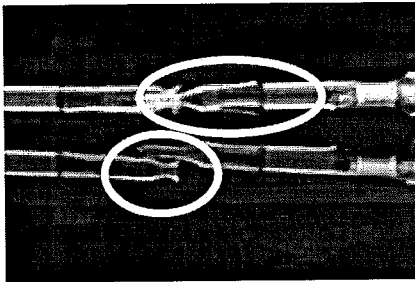
The motor board wiring harnesses may not be making an adequate connection due to pins that have backed out of the wiring harness housing or pins that are not centered correctly within the wiring harness housing. With this inadequate connection Viper units can experience several errors that are shown on the user interface as "No Motor," "Motor Stall," or "MTR Comm Err."

X-Ray view of improper pin alignment

All Viper units manufactured after April 29, 2013, with serial numbers after **62C1322VP005** (22nd week of 2013) have had new wiring installed for each motor and motor board. If you have a Viper that was manufactured before the above date and before the above mentioned serial number, that is experiencing a large number of "No Motor", "Motor Stall", or "MTR Comm Err", individual wiring is now available for each motor. Please note the different part numbers for each motor, as each motor should have a different identification on the wire to aid in troubleshooting once the new wiring is installed. New wiring part numbers are as follows:

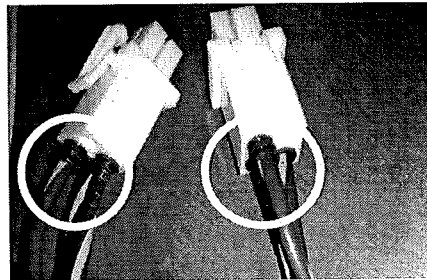
View of pins backing out of the housing

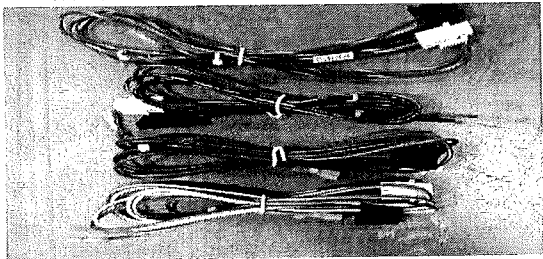
Bundle Harness will be replaced, with a single harnesses (see part numbers above).

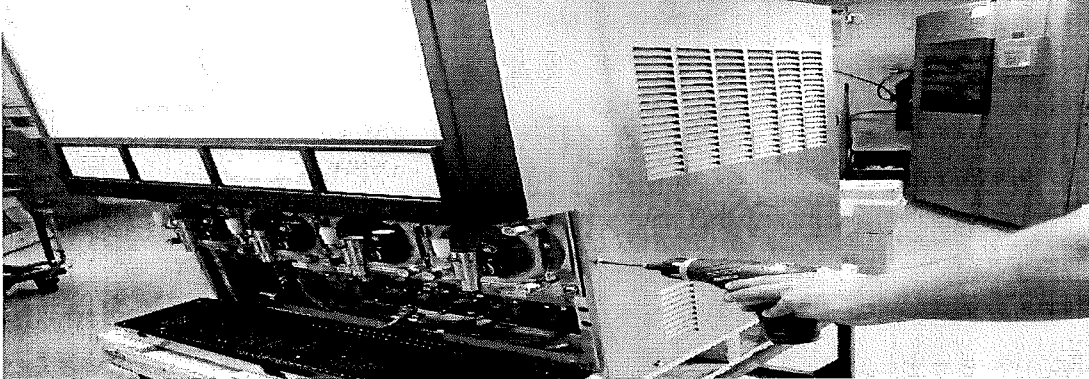
1. Unplug the unit and follow all appropriate shutdown and lockout procedures.
2. Depressurize syrup, water, and CO2 on the unit.
3. Get access to all sides of unit.
4. Remove 3 screws from both sides and 4 at the back of the unit to remove the panels

5. Remove all panels as shown
6. Disconnect all harnesses from the motors and capacitors
7. Review all harnesses connected to the motor, especially for the barrel that was identified with the error message. Look for pins that have backed out of the housing on the harness or motor housing or have pins that are not centered in the housing (Reference pictures above).

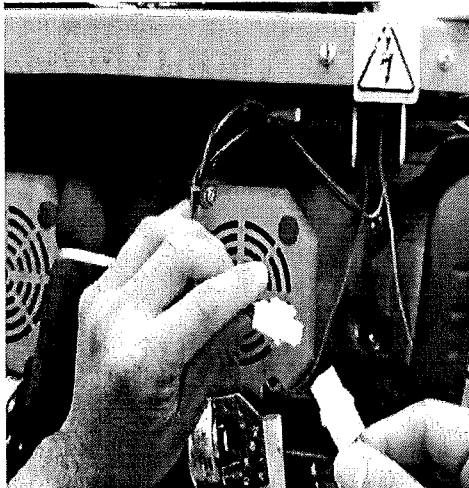
8. Lift the merchandiser, open the E-box, and flip the black board shield back.

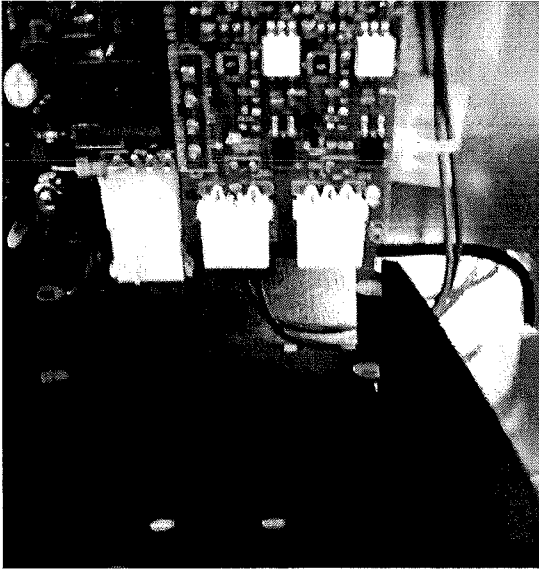
9. Disconnect and remove the harnesses from the motor board.

10. Carefully pull the harness out the back of the unit (if done without care, there is potential to damage other wires and connectors).
11. Scrap out harnesses removed.

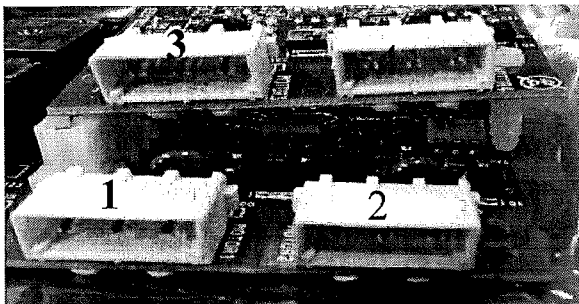
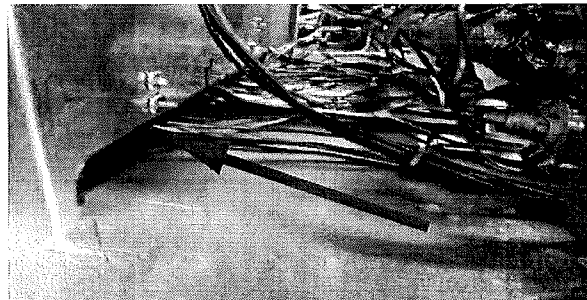
Repeat steps 2, 3 and 4 above for the motor harness number 3&4 (Plumb in the harness number 3&4 behind the filter copper tube to the board. (See picture)).

Expander board is attached to 3 and 4 motor units only. The plug in locations are marked with 1, 2, 3, or 4
